Sample Home Inspection Report

Inspection Date:
10-01-11

Inspection Address:
123 Maple Street
Anytown USA

Report Number:
100111B

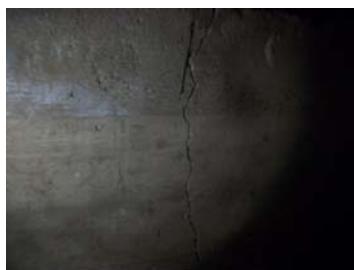
A moderate sized crack was visible in the foundation basement wall. We observed no related conditions suggesting the need for immediate repair. This crack should be monitored, and if ongoing movement is observed, further review would then be recommended.

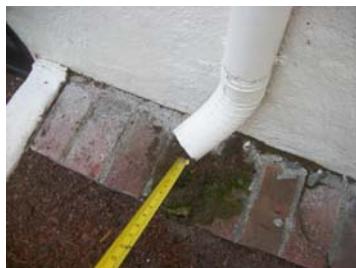
Picture represents several downspouts

2. Several of the downspouts were not properly extended. This condition will allow roof water to pool near the foundation that often leads to excess moisture around the foundation or in the basement and/or underbuilding crawl space. The discharge from all downspouts should be routed sufficiently away from the structure (usually at least 6' to 10') to prevent puddling, pooling, and saturation of the soil around the building.

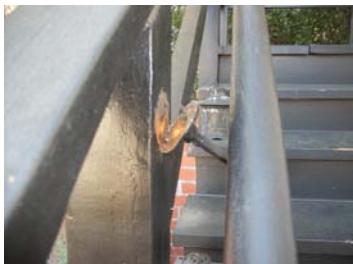
Railings up to guest room over garage were damaged. The damaged railings should be repaired, if possible or replaced if necessary to provide adequate protection from personal injury for persons in the area.

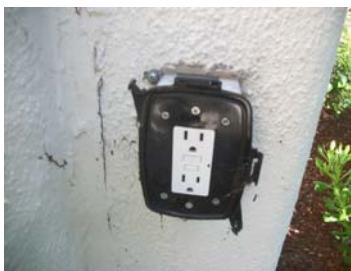
The outdoor receptacle right side main house, and its box were not rated for exterior use. To reduce the potential for deterioration of the receptacle and wiring and attendant safety hazards, we recommend replacement with an appropriate exterior-rated receptacle and weather-resistant box.

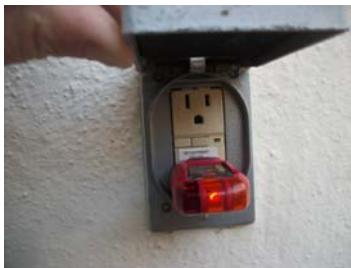
The GFCI receptacle right side at stairs up to guest house over garage , intended to provide Ground Fault protection to the exterior receptacles, did not trip when tested with its own "TEST" button. This may have been the result of improper wiring of the device or failure of its internal circuitry. The receptacle should be rewired to operate dependably, or it should be replaced to restore this critical protection.

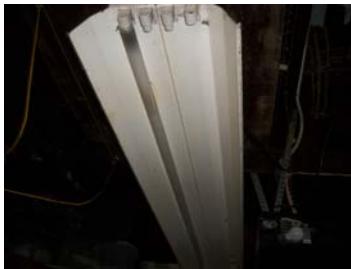
A light fixture was not working in the garage. The bulb in this fixture may be burned out. The bulb should be tested and replaced, if necessary. If the bulb is not burned out, the condition of the fixture and wiring should be verified.

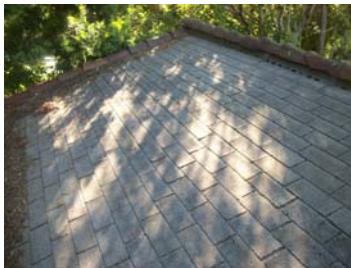
Portions of the surface granulation had washed away, and minor surface cracks had developed. These were normal signs of aging, and no action was needed at this time. However, loss of granules is a primary indicator of advanced age and deterioration and a reminder to start budgeting for eventual replacement of the roof covering.

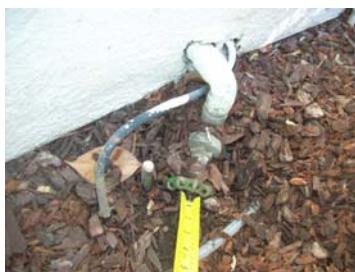
The main shut-off valve was partially buried. The valve should be fully exposed for ease of operation. This would be especially important in an emergency.

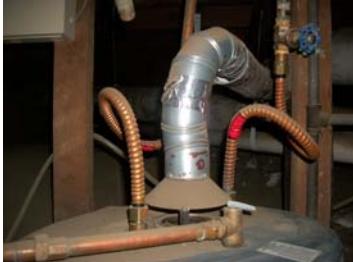
Represents Both water Heaters

The electrical system ground in this dwelling was bonded to the cold water supply piping on the water heater. However, there was no grounding "bridge" or "jumper" across to the hot water discharge piping as is current trade practice in this area. We recommend that a competent, licensed electrician install an appropriate bonding jumper.

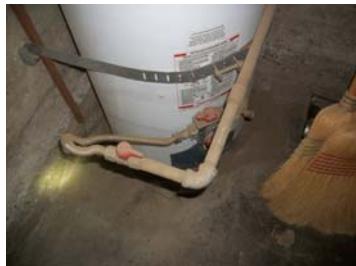
Both water heaters

17. The gas piping at both water heaters, which could become energized, was not properly bonded to the grounded side of the electrical system. We recommend that a competent, licensed electrician properly bond the gas piping in conformance with current industry standards.

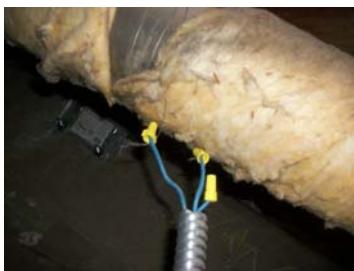
An open junction box was observed family room crawl space. All open junction boxes should be covered with an acceptable cover manufactured for the purpose to protect the wiring connections and reduce the risk of shock.

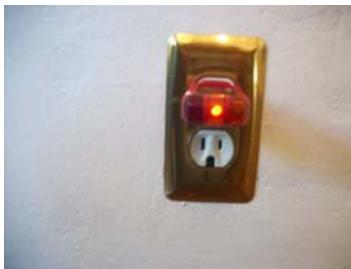
Picture represents several outlets

19. Ungrounded three-prong receptacles were observed in several areas. This can be a safety hazard. Ungrounded three-pronged receptacles should be grounded, restored to their original two prong configuration or upgraded with GFCI protection to reduce this risk. This work should be performed by a competent, licensed electrician and certified to be safe and dependable when completed.

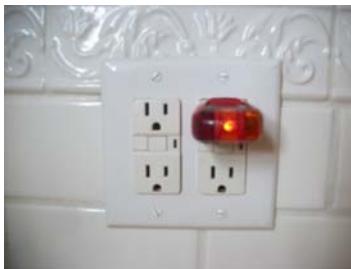
Represents all kitchen counter outlets

The GFCI protection all kitchen counter receptacles did not function properly when tested. GFCI protection should be re-established for this area for an increased margin of safety.

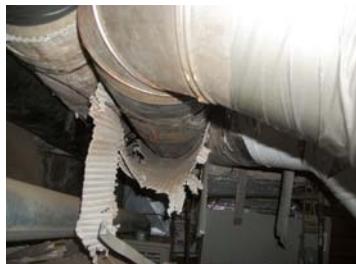
Portions of the duct insulation were damaged. The insulation in question should be replaced to minimize heat loss.

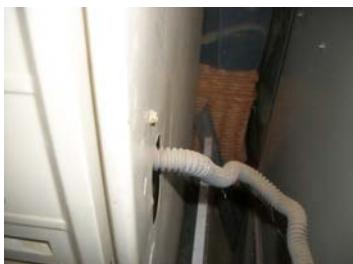
The flexible gas connector that supplied this heating unit passed through a hole in the metal cabinet. This is not a generally accepted configuration, as the metal of the cabinet could cut the section of the connector passing through the hole, should the connector be bumped or jostled. As an upgrade, at the next regular servicing, we recommend extending the supply piping with additional rigid pipe, approved for the purpose, from the appliance inside the cabinet out through the hole, so that the connector can remain *entirely* on the outside of the cabinet. A competent, licensed plumber or heating technician should do the work, in accordance with accepted trade practices.

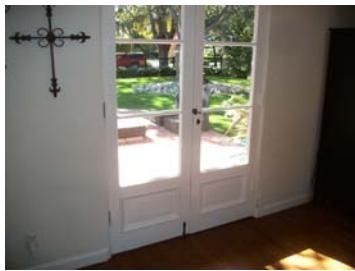
Picture represents Several interior & exterior doors

25. Several of the doors throughout the dwelling were in need of attention. We recommend adjustment, trimming, restoration, or replacement of interior doors as required, for smooth operation and full function.

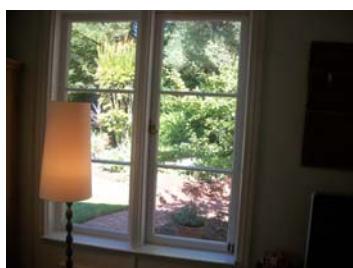
Picture represents Many windows

26. Several of the windows were stuck or had been painted shut and could not be opened. All stuck windows should be repaired to restore functional use. Careful work with a razor knife may be sufficient.

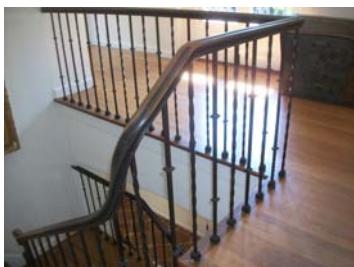
The stair railing was loose. The railings should be reinforced or replaced to make them capable of resisting the lateral force from an average person's weight.

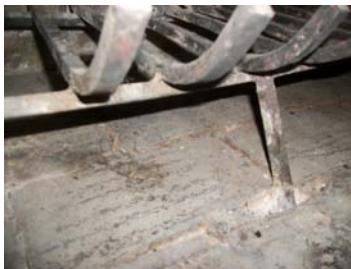
Some of the firebricks in the firebox of the fireplace were badly cracked and/or loose. All loose mortar in the firebox should be removed and new mortar installed. This is known as "tuck pointing." Also, in the course of this work, any badly cracked or deteriorated firebrick should also be replaced.

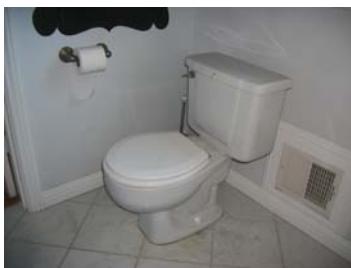
The toilet Master bedroom bath was not securely attached to the soil pipe flange at the floor. While no damage was evident, this condition should be addressed so that leakage does not develop and cause damage. A competent, licensed plumber should remove the toilet, inspect the floor for damage, and after repair of any floor damage, reset the toilet, securely to the floor, using a new bowl wax.

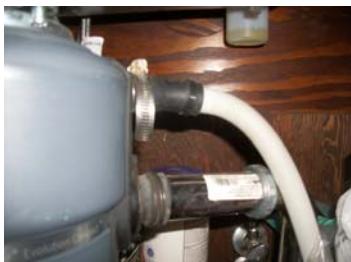
The dishwasher drain lacked an adequate separation, as required by present standards. This condition raised suspicion of an installation by non-professionals and/or a possible lack of building permits and inspection. An approved air-gap, high loop or standpipe should be installed.
