Sample Home Inspection Report

Inspection Date:
10-01-11

Inspection Address:
123 Maple Street
Anytown USA

Report Number:
100111B

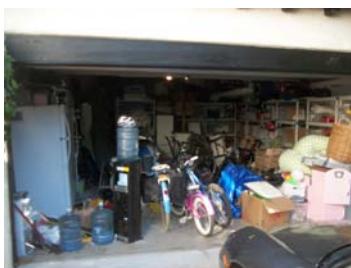
A light fixture was not working in the garage. The bulb in this fixture may be burned out. The bulb should be tested and replaced, if necessary. If the bulb is not burned out, the condition of the fixture and wiring should be verified.

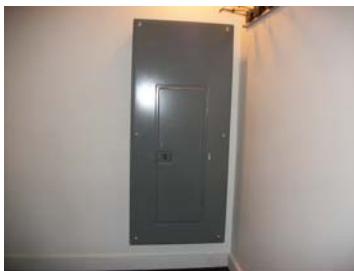
An additional distribution panel, or subpanel was located top of basement stairs.

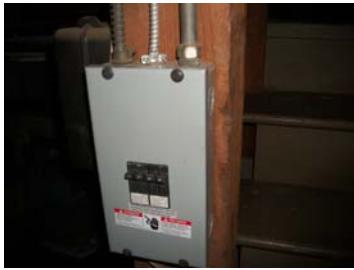
A third distribution panel, or second subpanel, was located basement bottom of stairs.

◀ The inspected circuitry in both subpanels was in acceptable condition.

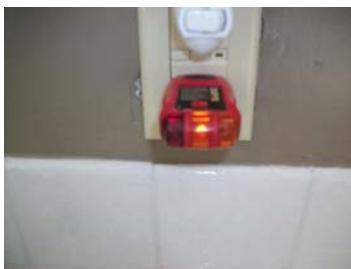
Picture represents all bathroom outlets

The GFCI protection Master bedroom bath did not function properly when tested. GFCI protection should be re-established for this area for an increased margin of safety.

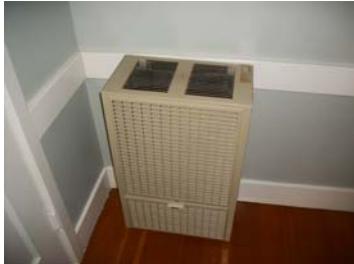
A wall heater was installed in a sleeping room. Present standards may no longer permit this arrangement. For maximum safety, upgrading the heating in this bedroom to conform to modern standards is recommended.
